# Manhole Inspection Summary

Manhole # S55M\_\_006MH

Insp Date: **10/27/08 2:11 PM**

**Location** Address: **3700 odonnell st**

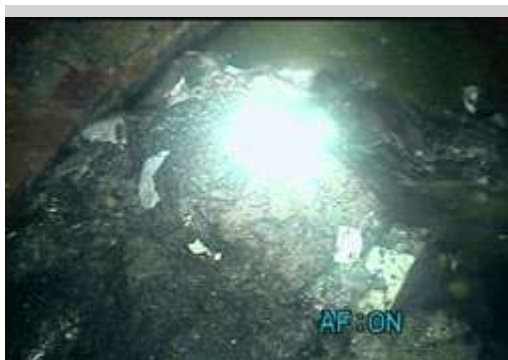
Defect 3

Condition: ☐ Sound ☐ Cracked ☐ Root Intrusion ☐ Deteriorated ☐ Leaks ☒ **Debris**

channel debris

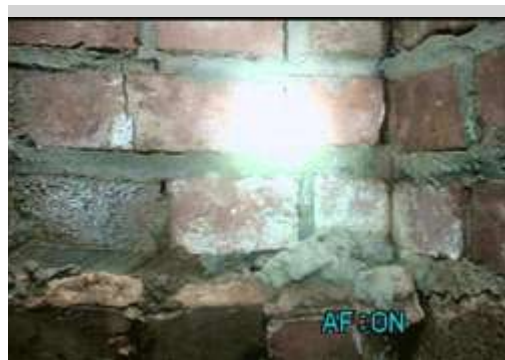
Defect 2

Condition: ☐ Sound ☒ **Cracked** ☐ Root Intrusion ☐ Loose Brick ☒ **Deteriorated**

corbel cracked and deteriorated

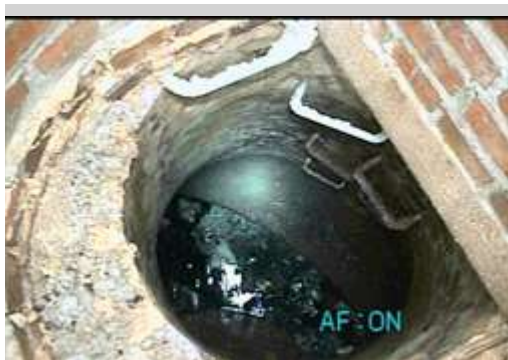
Defect 1

Count: **6** Missing: **0** ☒ **Corroded**

cor. steps

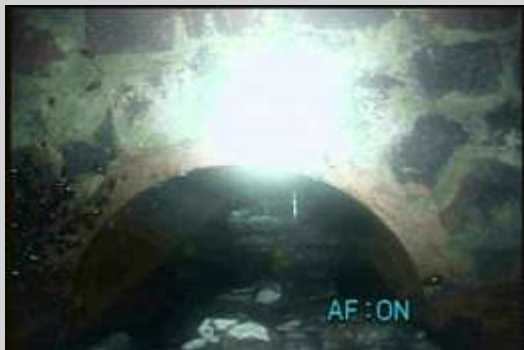
12 O'Clock Outflow

Deposits: ☐ None ☐ Mud ☐ Sludge ☒ **Debris** ☐ Grease

Silt Depth: 3 (in.) Deposits Extent: **Light**

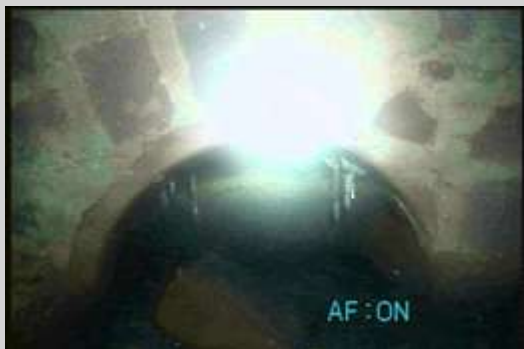
4 O'Clock Inflow

couldnt get better pic due to steam

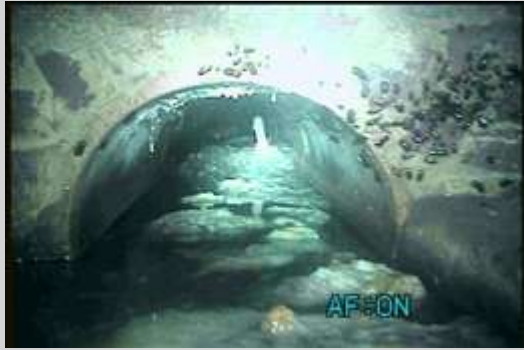
5 O'Clock Inflow

Deposits: ☐ None ☐ Mud ☐ Sludge ☒ **Debris** ☐ Grease

Silt Depth: **4** (in.) Deposits Extent: **Light**
